PISTON SEIZURES EXPLAINED

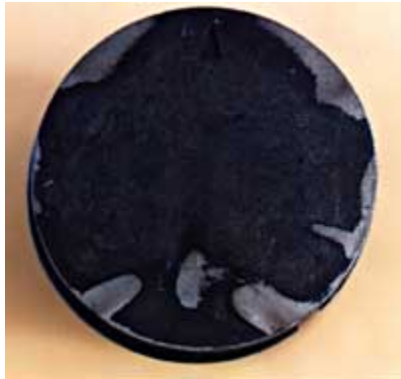
PERFECT BROWN CROWN

The crown of this piston shows an ideal carbon pattern. The transfer ports of this two-stroke engine are flowing equally and the colour of the carbon pattern is chocolate brown. That indicates that this engine's carb is jetted correctly.

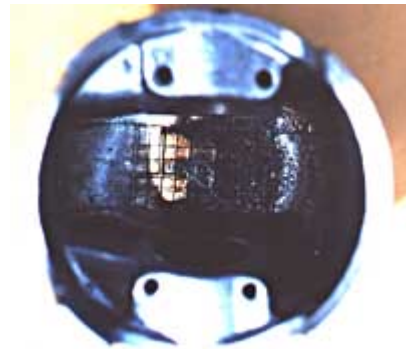
BLACK SPOT HOT

The underside of this piston has a black spot. The black spot is a carbon deposit that resulted from pre-mix oil burning on to the piston because the piston's crown was too hot. The main reasons for this problem are overheating due to too lean carb jetting or coolant system failure.

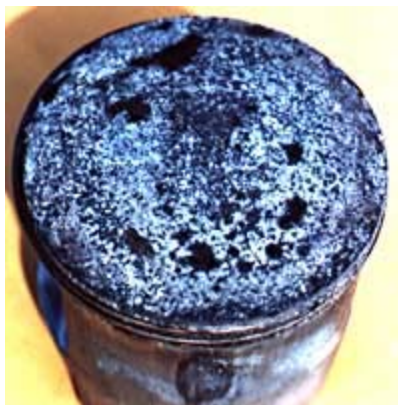
ASH TRASH

This piston crown has an ash colour, which shows that the engine has run hot. The ash colour is actually piston material that has started to flash (melt) and turned to tiny flakes. If this engine was run any longer, it probably would've developed a hot spot and hole near the exhaust side and failed. The main causes of this problem are too lean carb jetting, too hot spark plug range, too far advanced ignition timing, too much compression for the fuel's octane, or a general overheating problem.

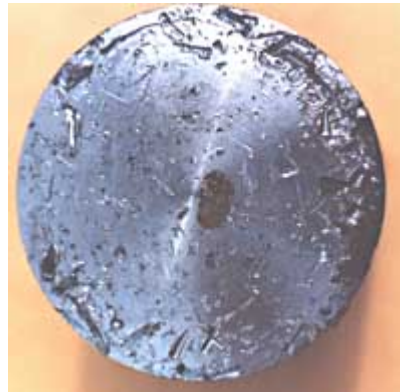
SMASHED DEBRIS

This piston crown has been damaged because debris entered the combustion chamber and was crushed between the piston and the cylinder head. This engine had a corresponding damage pattern on the head's squish band. The common causes of this problem are broken needle bearings from the small or big end bearings of the connecting rod, broken ring ends, or a dislodged ring centring pin. When A problem like this occurs, it's important to locate where the debris originated. Also the crankcases must be flushed out to remove any left over debris that could cause the same damage again. If the debris originated from the big end of the connecting rod, then the crankshaft should be replaced along with the main bearings and seals.

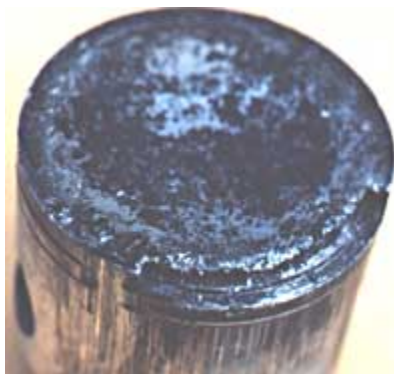
CHIPPED CROWN DROWNED

This piston crown chipped at the top ring groove because of a head gasket leak. The coolant is drawn into the combustion chamber on the down-stroke of the piston. When the coolant hits the piston crown it makes the aluminium brittle and it eventually cracks. In extreme cases the head gasket leak can cause erosion at the top edge of the cylinder and the corresponding area of the head. Minor leaks of the gasket or o-ring appear as black spots across the gasket surface. An engine that suffers from coolant being pressurized and forced out of the radiator cap's vent tube is a strong indication of a head gasket leak. In most cases the top of the cylinder and the face of the cylinder head must be resurfaced when a leak occurs. Most mx bikes have head stays mounting the head to the frame. Over time the head can become warped near the head stay mounting tab, because of the forces transferred through the frame from the top shock mount. It's important to check for warpage of the head every time you rebuild the top end.

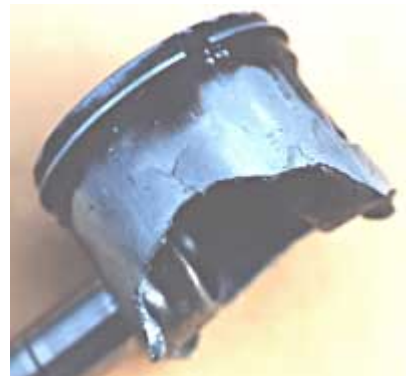
SHATTERED SKIRT

The skirts of this piston shattered because the piston to cylinder clearance was too great. When the piston is allowed to rattle in the cylinder bore, it develops stress cracks and eventually shatters.

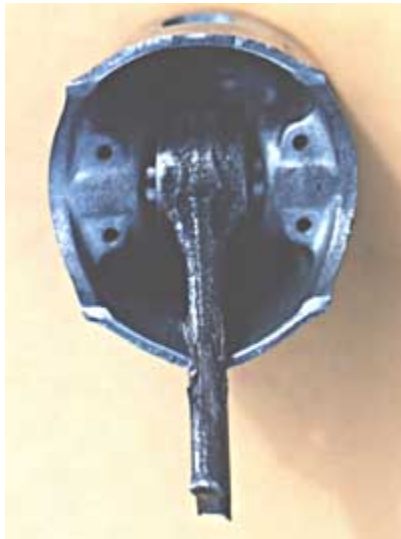
SNAPPED ROD

The connecting rod of this engine snapped in half because the clearance between the rod and the thrust washers of the big end was too great. When the big end bearing wears out, the radial deflection of the rod becomes excessive and the rod suffers from torsion vibration. This leads to connecting rod breakage and catastrophic engine damage. The big end clearance should be checked every time you rebuild the top end. To check the side clearance of the connecting rod, insert a feeler gauge between the rod and a thrust washer. Check the maximum wear limits in your engine's factory service manual.

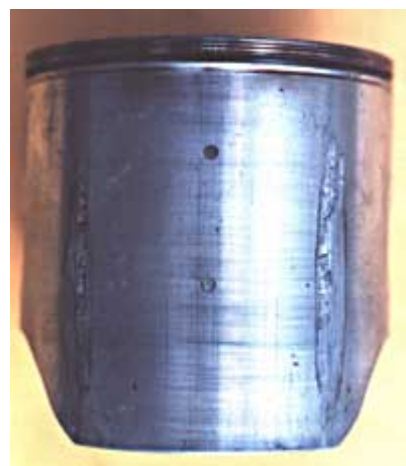
FOUR-CORNER SEIZURE

This piston has vertical seizure marks at four equally spaced points around the circumference. A four-corner seizure is caused when the piston expands faster than the cylinder and the clearance between the piston and cylinder is reduced. Another common problem of this type is a single point seizure on the centre of the exhaust side of the piston. However this occurs only on cylinders with bridged exhaust ports. The main causes for this problem are too quick warm-up, too lean carb jetting (main jet), or too hot of a spark plug range.

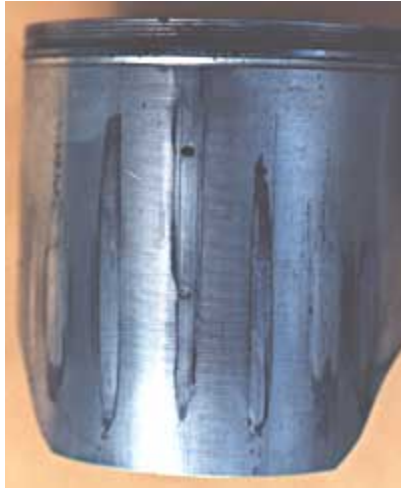
MULTI-POINT SEIZURE

This piston has many vertical seizure marks around the circumference. This cylinder was bored to a diameter that was too small for the piston. As soon as the engine started and the piston started its thermal expansion, the piston pressed up against the cylinder walls and seized. The optimum piston to cylinder wall clearances for different types of cylinders varies greatly. For example a 50cc composite plated cylinder can use a piston to cylinder wall clearance of .0015 inches, whereas a 1200cc steel-sleeved cylinder snowmobile set-up for grass drags will need between .0055 to .0075 inches. For the best recommendation on the optimum piston to cylinder clearance for your engine, look to the specs that come packaged with the piston or consult your factory service manual.

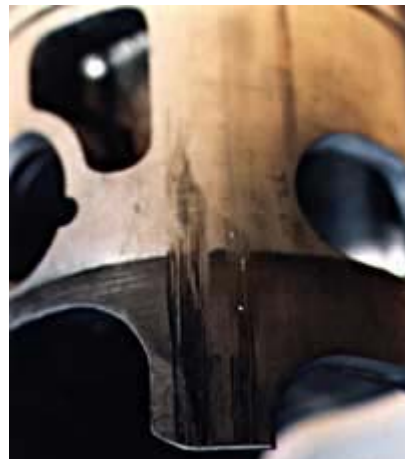
INTAKE SIDE SEIZURE

This piston was seized on the intake side. This is very uncommon and is caused by only one thing, loss of lubrication. There are three possible causes for loss of lubrication, no pre-mix oil, separation of the fuel and pre-mix oil in the fuel tank, water passed through the air-filter and washed the oil film off the piston skirt.

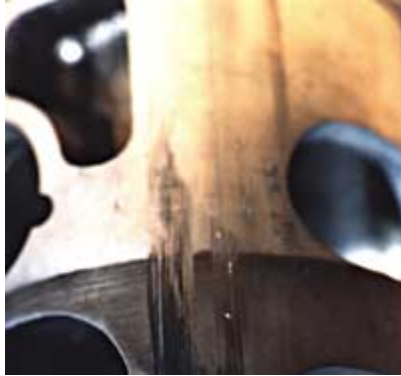
COMPOSITE FLAKING

Most two-stroke cylinders used on motorcycles and go-karts have composite plated cylinders. The composite material is made of tiny silicon carbide particles. The electro-plating process enables the silicon carbide particles to bond to the cylinder wall. The particles are very hard and sharp; they don't bond to the ports so the manufacturer or reconditioning specialist must thoroughly clean the cylinder. Sometimes the silicon carbide "flashing" breaks loose from the ports and becomes wedged between the cylinder and the piston. This causes tiny vertical scratches in the piston. This problem isn't necessarily dangerous and doesn't cause catastrophic piston failure, but it should be addressed by thoroughly flushing the cylinder and ball-honing the bore to redefine the cross-hatching marks. Normally you will need to replace the piston kit because the scratches will reduce the piston's diameter beyond the wear spec.

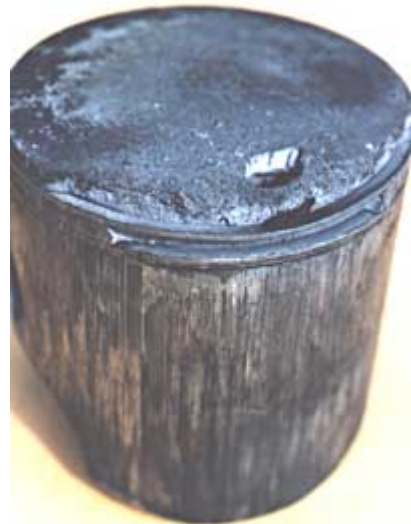
BURNT-OUT BLOW-HOLE

This piston was overheated so badly that a hole melted through the crown and collapsed the ring grooves on the exhaust side. Normally the piston temperature is higher on the exhaust side so catastrophic problems will appear there first. There are several reasons for a failure like this, here are the most common; air-leak at the magneto side crankshaft seal, too lean carb jetting, too far advanced ignition timing or faulty igniter box, too hot of a spark plug range, too high of a compression ratio, too low octane fuel.

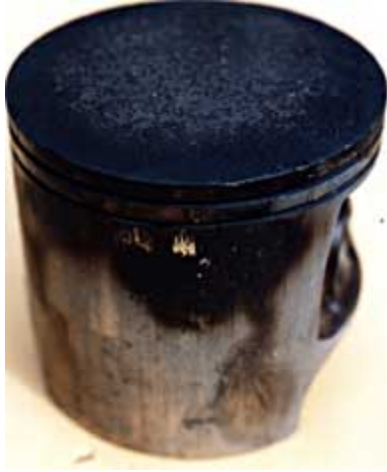
BLOW-BY

This piston didn't fail in operation but it does show the most common problem, blow-by. The rings were worn past the maximum ring end gap spec, allowing combustion pressure to seep past the rings and down the piston skirt causing a distinct carbon pattern. It's possible that the cylinder walls cross-hatched honing pattern is partly to blame. If the cylinder walls are glazed or worn too far, even new rings won't seal properly to prevent a blow-by problem. Flex-Hones are a product available at most auto parts stores. They can be used to remove oil glazing and restore cross-hatch honing marks that enable the rings to wear to the cylinder and form a good seal. If you purchase a Flex-Hone for your cylinder, the proper grit is 240 and the size should be 10% smaller than the bore diameter.
