User Prospective On Gasoline Fuel Specifications

Dr. D.S.Khatri
Engineering Division
Maruti Udyog Ltd.

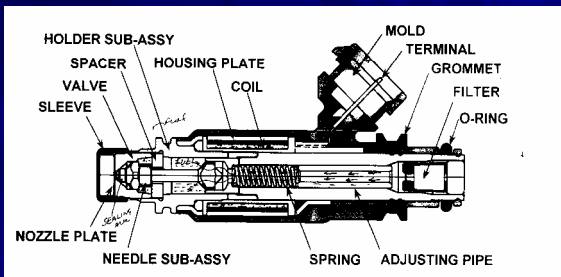
Fuel Injector Failure

- Problem reported:- Poor pickup, engine misfiring.
- Injector fuel flow rate low.
- Brown deposit at injector tip.
- Rusted needle.
- Cause:- H₂O, "S"
